Washington State Department of Ecology Hazardous Waste and Toxics Reduction Program

RCRA Site ID: WAH000050091	Facility Name: Treoil Industries	Inspection Date: March 6, 2017
Generator Status: LQG	Facility Address: 4242 Aldergrove Rd., Ferndale WA 98248	Date Report Sent:

PHOTO LOG

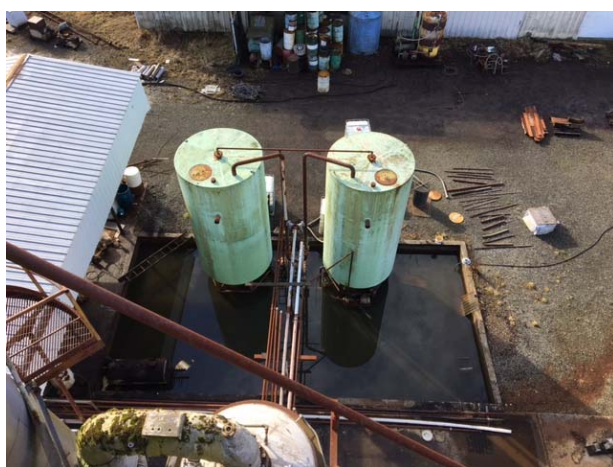
#3 Site Overview

Two green tanks with contents, sitting in secondary containment. Hose from containment was actively draining water to the southwest side of the property. Drums seen at the top of the photo were mostly full yet unlabeled.

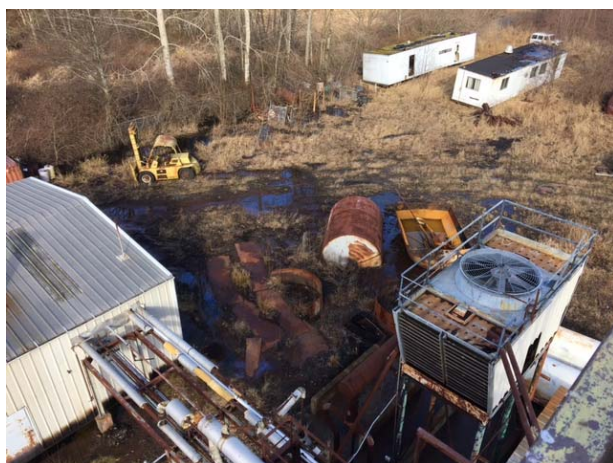
#4 Site Overview

Metal pieces, tanks on sides, and two white empty mobile home style trailers (right one held lab).

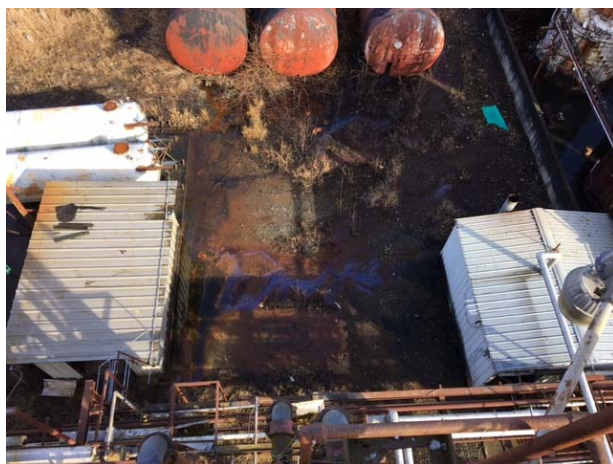
#5 Site Overview

Two white tanks on their sides are open at the bottom and empty. The three reddish tanks appeared to contain tall oil. The one on the right was actively leaking onto the ground. These tanks were open at the top so likely contain rain water and waste. The small building to the right houses a boiler.

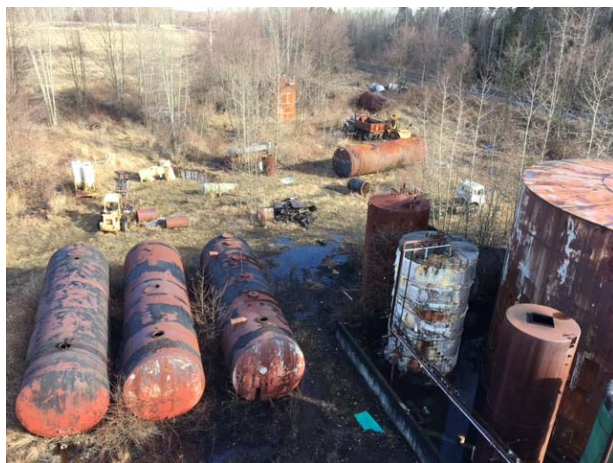
#6 Site Overview

Another view of the tanks shown in photo 5, plus tanks in the tank farm secondary containment. Also visible in this photo is equipment and tanks to the north.

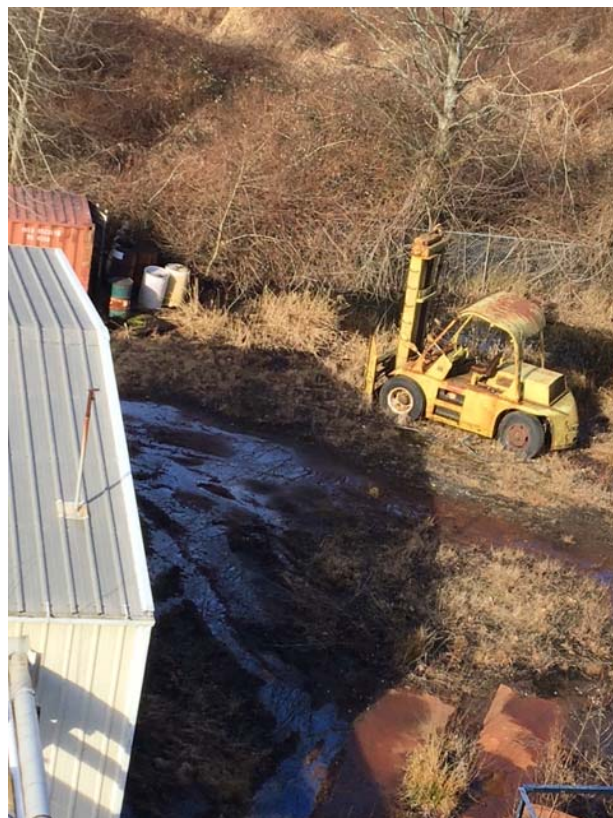
#7 Site Overview

North and northwest view of the north-south warehouse area. The “North Sump” is located due west of the northwest corner of this building, in the blackberries west of the fence and red conex container.

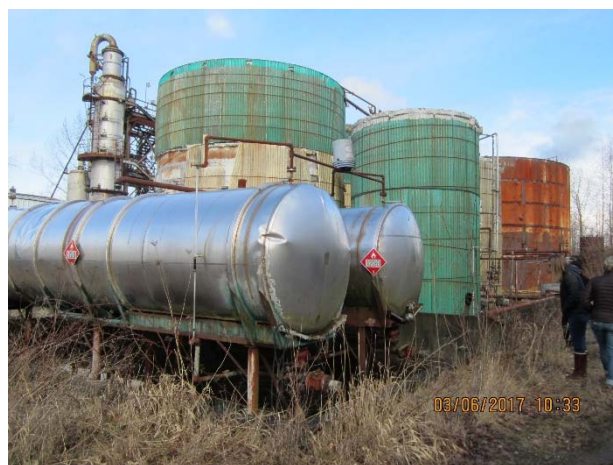
#9 Tank Farm

The two silver tanks once contained glycerin but are now empty.

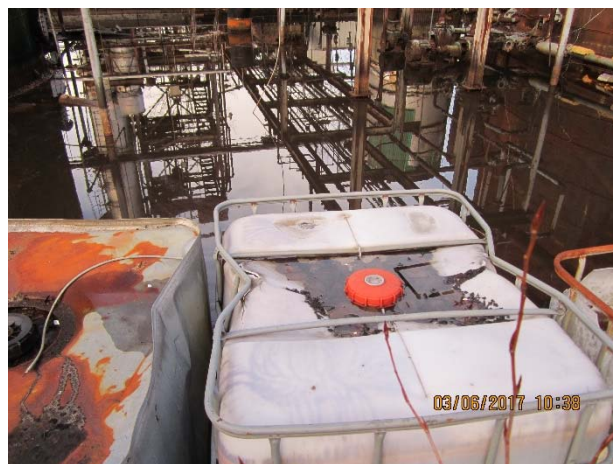
#11 Tank Containment

Three totes within the containment all held unknown contents. The tote to the right of the photo was open at the top, and the contents were solid. Water in secondary containment has the appearance of rainwater, with no observable oil floating on the surface.

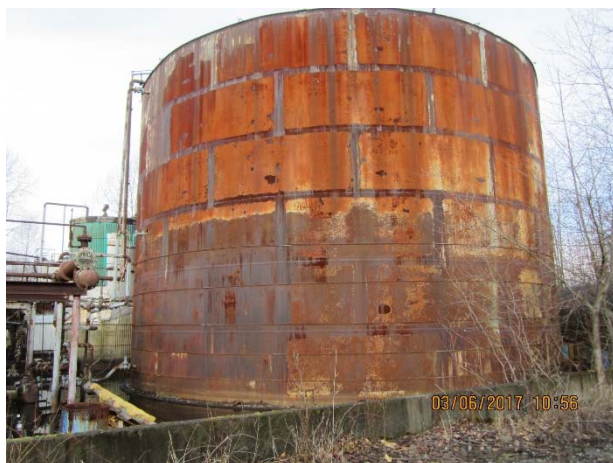
#14 Tank Farm

200,000 Gallon Tank which appeared to have contents up to five feet deep (thermal imagery and knocking). Assumed to be tall oil (based on site guide and past reports).

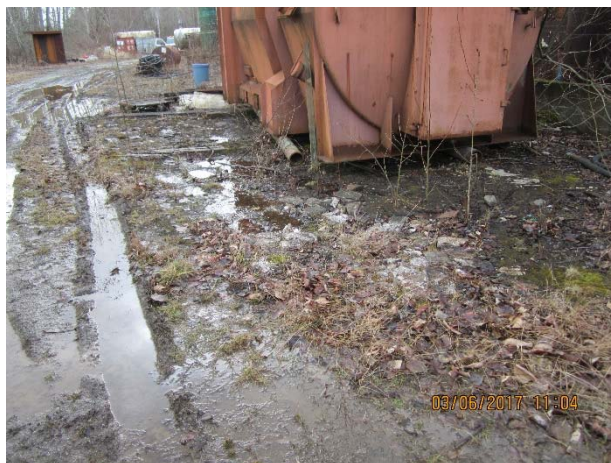
#15 Northeast of Tank Farm

Documenting grey material on ground, with the appearance of refractory material. Tank is thought to have been one of the incinerators mentioned in past reports, and is open and empty.

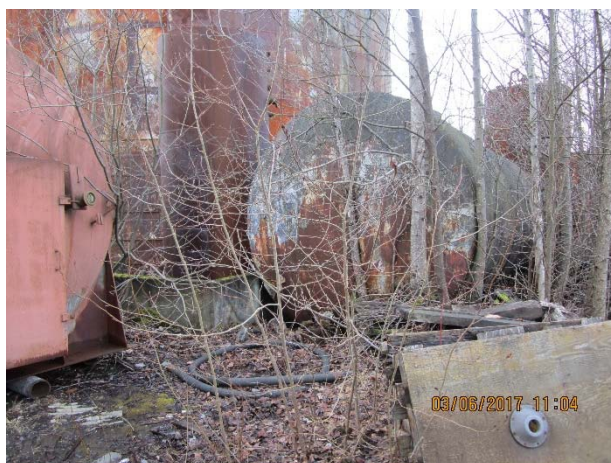
#16 North of Tank Farm

This grey tank is just outside the north wall of the tank farm. Appeared to have contents. Rusty upright 2,000 gallon tank just inside the northeast corner of containment appeared to be approximately half full (up to 7 – 8 feet, noted by knocking on walls).

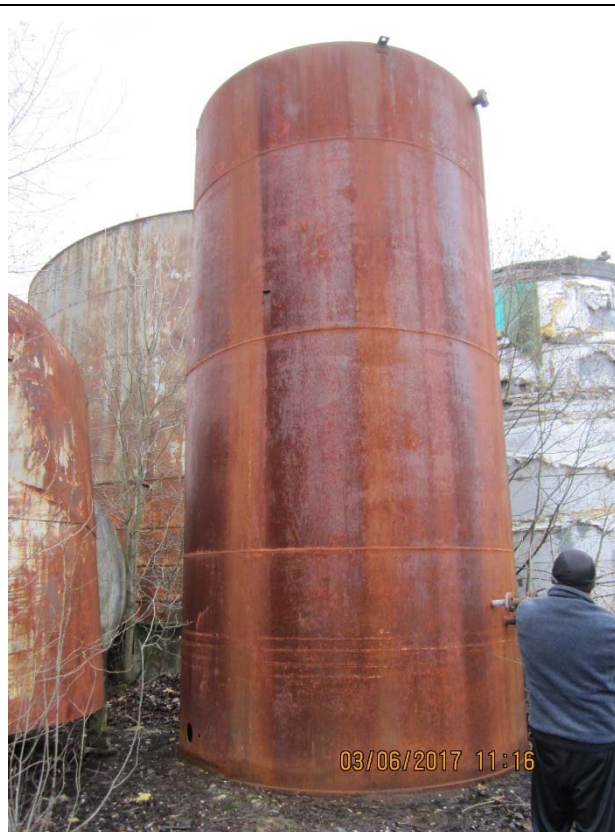
#17 Outside of NW Corner of Tank Containment

This tank appeared to have a tank within the tank, elevated a few feet off the ground. The tank appeared (thermal imagery) to be full.

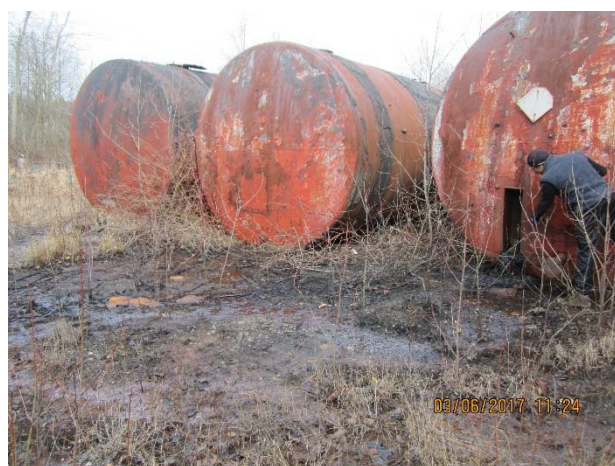
#18 Tanks NW of Tank Containment

These tanks appeared to have contents, though were open at top (visible from above: see photo 6). The tank to the right is actively leaking tall oil from the port.

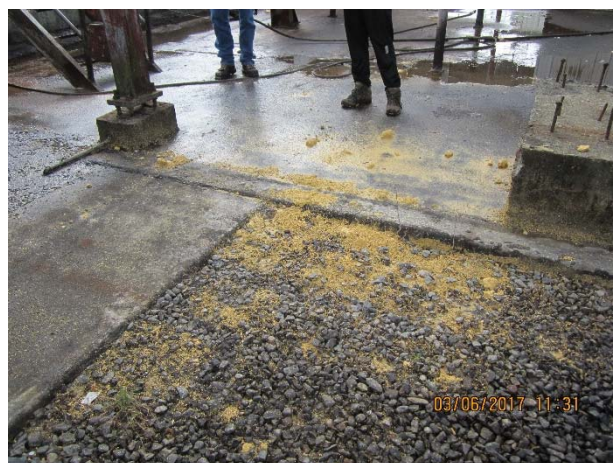
#20 Central Pad, West of Tank Containment

Possible asbestos pipe insulation on pad and gravel beneath pipes.

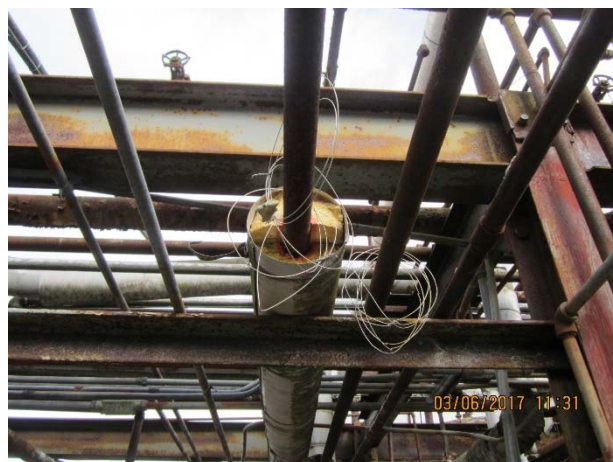
#21 Central Pad, West of Tank Containment

Pipes overhead area of pad impacted by crumbled insulation, shown in photo 20.

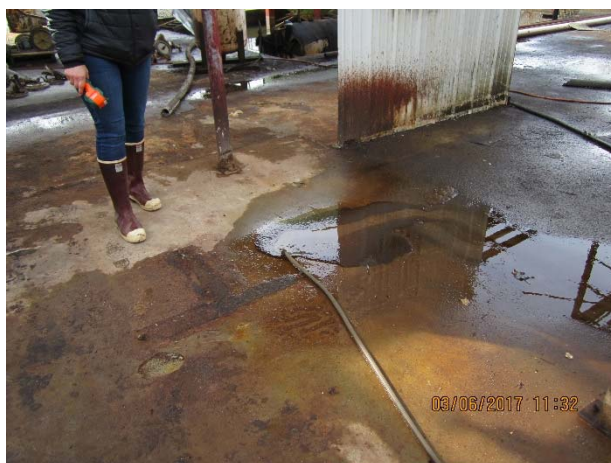
#23 Central Pad West of Tank Containment

Hose shown in photo 22, actively discharging water from containment to pad.

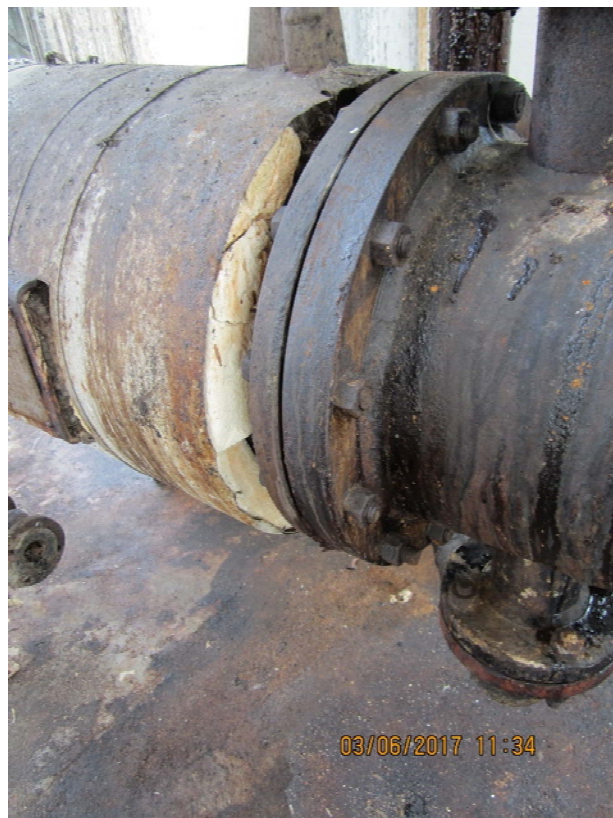
#24 Pipe Insulation

Close up of more pipe insulation.

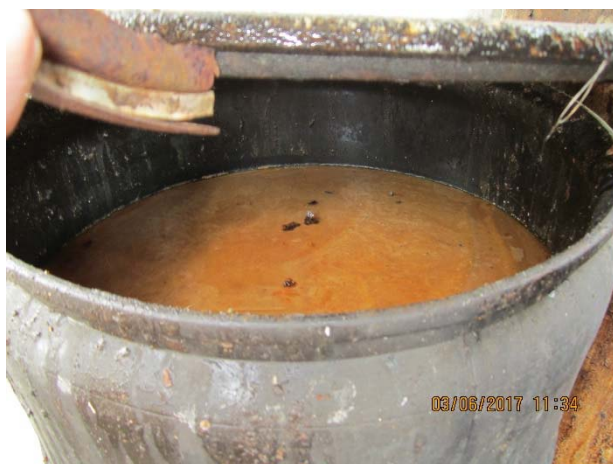
#25 Central Pad, Under Partial Roof

The lid on this 55-gallon drum was lifted to observe an orange, oily substance.

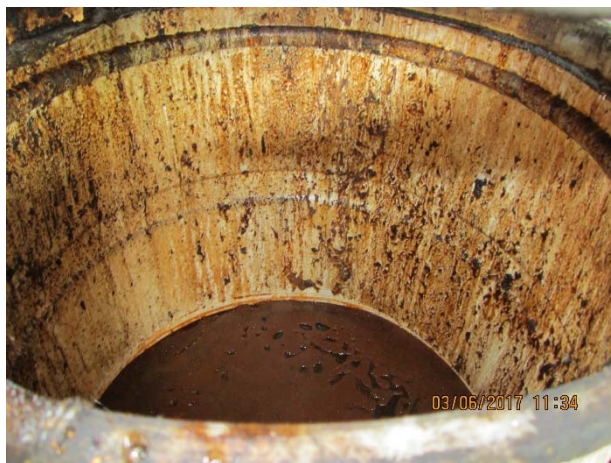
#26 Central Pad, Under Partial Roof

Another drum found under the partial roof contained a blacker oily substance which could have been tall oil.

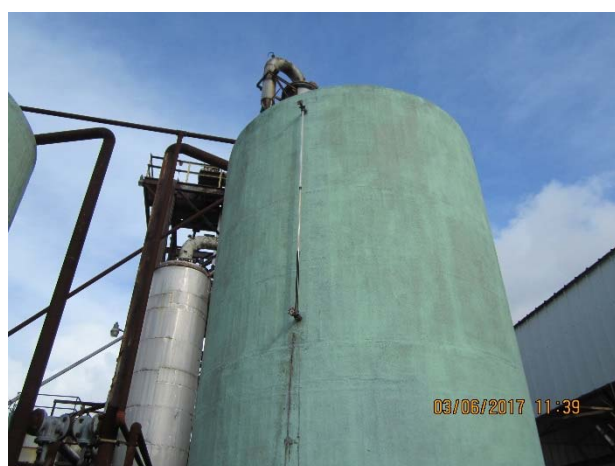
#32 Central Area, SW of Tank Farm

One of two tanks located in the former "biodiesel well" containment area. This tank had a glass gauge along the side which indicated that the contents were separated into two distinct layers, with around 1/3 being a light brown liquid, and 2/3 a very dark oil. Solution drained from the tank's spigot had an unexpected pH of around 3 (tested using pH paper).

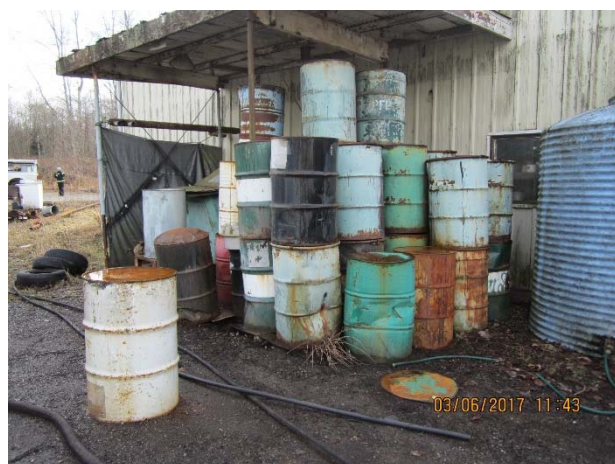
#33 East – West Warehouse, North Side

Drums stacked along the north side of the 60' X 100' warehouse were either full or empty (not all were checked). None were labeled.

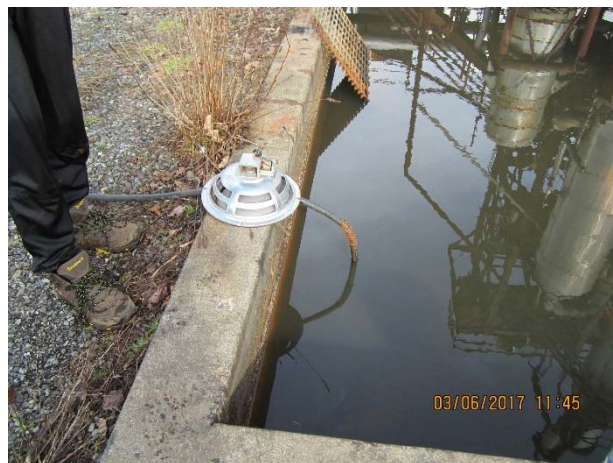
#34 Biodiesel Containment, South of Pad

A hose inserted in the containment water was discharging water to the southwest area of the property, in the direction of the south sump (see photo 35).

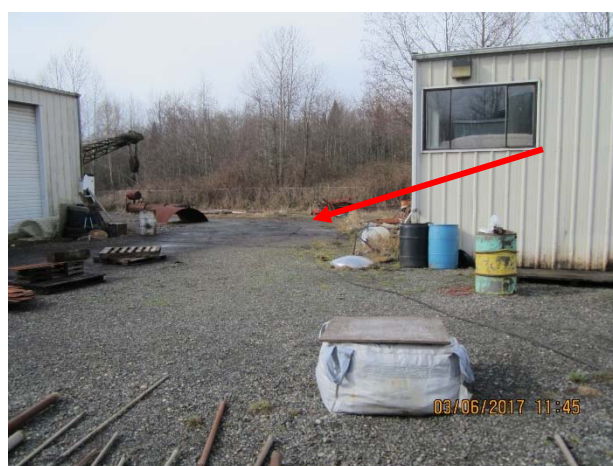
#35 Southwest Corner, Viewed from Biodiesel Containment

The hose seen in photo 34 was actively discharging water to the area indicated on the photo.

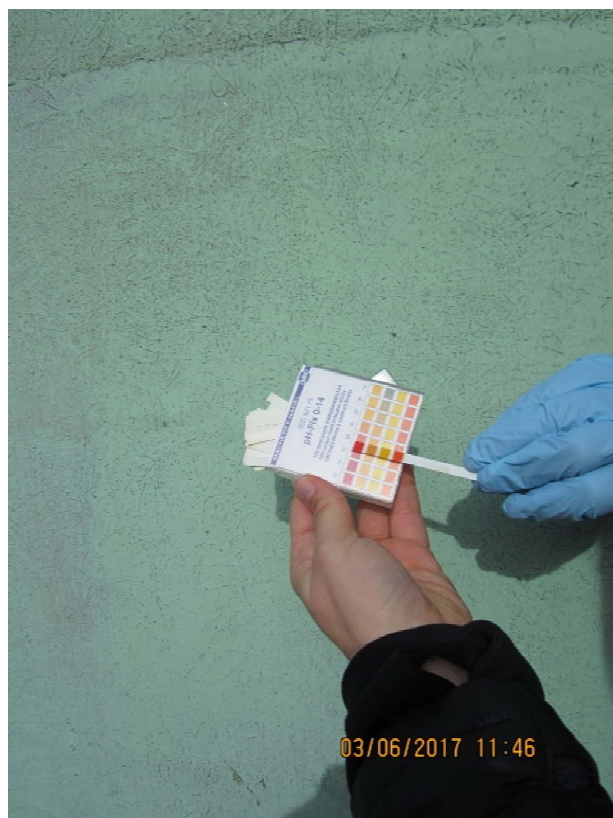
#36 Central Area, SW of Tank Farm

Liquid from the green tank shown to the right on photo 32 was drained into a container and tested using pH paper. The color indicated that it was in the pH 3 range. The contents of the green tank to the left of this one were also tested and appeared to have a neutral pH in the 6 – 7 range.

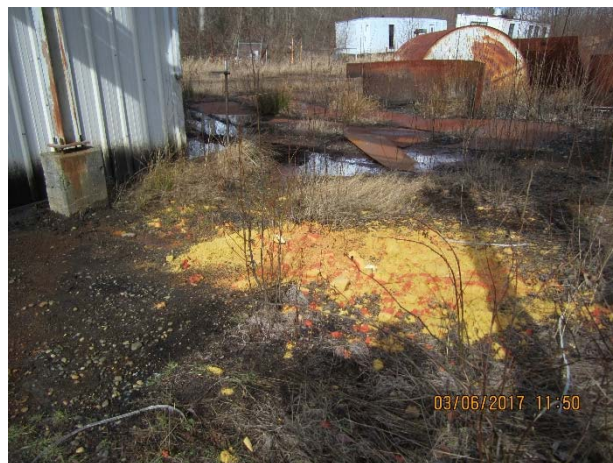
#38 Central Area, East of North-South Warehouse

Pipe insulation that has fallen from overhead pipes.

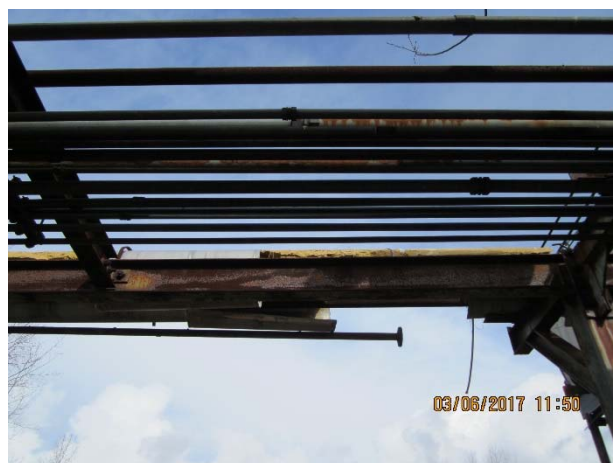
#39 Central Area, East of North-South Warehouse

Pipe overhead area of impacted ground shown in photo 38.

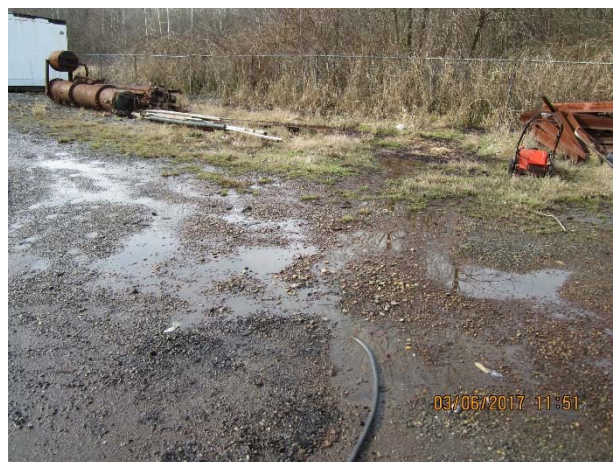
#40 View of SW Corner, Fenceline

End of hose shown in photos 34 and 35. The "south sump" is located just north and outside of the fence near the corner of the white trailer seen in the back of this photo.

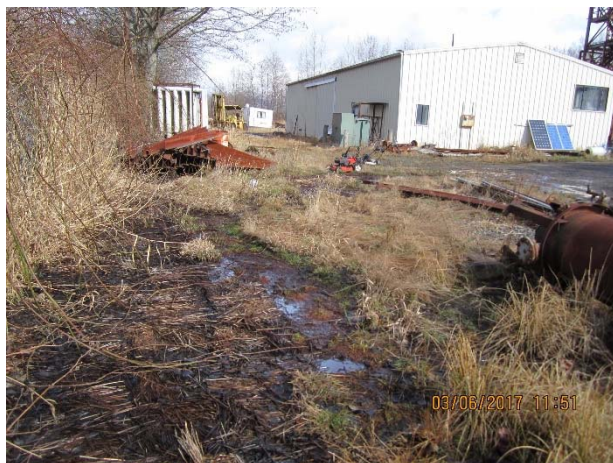
#41 SW Corner of Property

North-south warehouse in background; saturated soil just inside SW corner of fence, adjacent to “south sump.” Note that this area does not appear to have tall oil on the surface at this time, but has been seen here during past inspections.

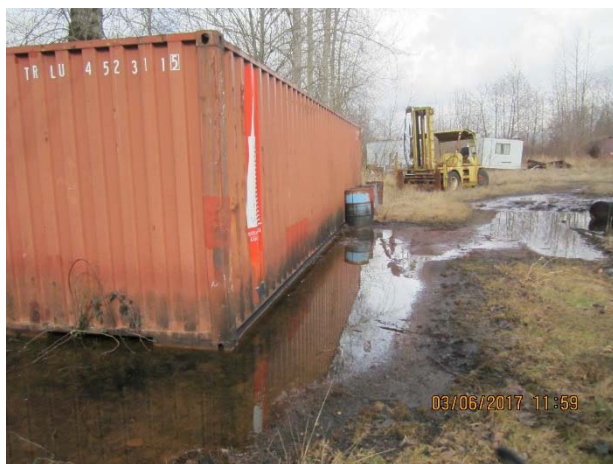
#43 West Fence-line Conex

Conex container surrounded by standing water, with seven 55-gallon drums sitting along the east side and one in front of the container (see also photo 81).

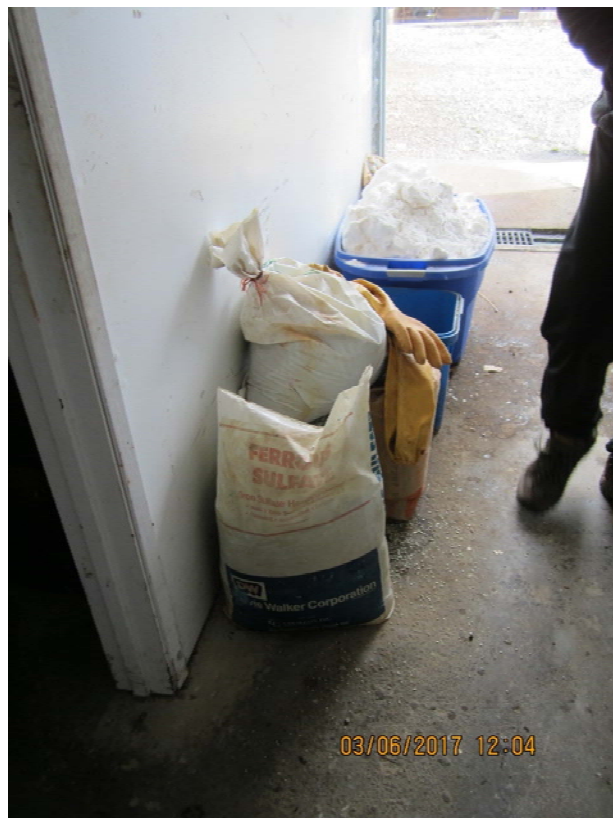
#44 North – South Warehouse

Chemicals located just inside the entrance to the warehouse. Noted in this area were ferrous sulfate, and other unknown substances. The white powder seen in the blue tub appeared to have a pH of 10 (using pH paper and water found in a bucket that had a pH of 7).

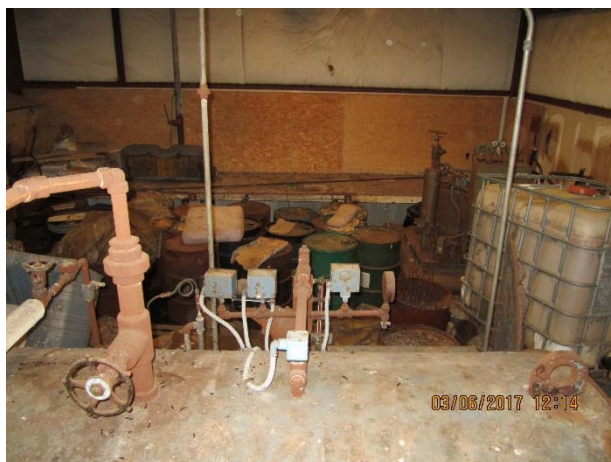
#57 East – West Warehouse

None of the drums in this photo were labeled to indicate contents. Access to this area was limited.

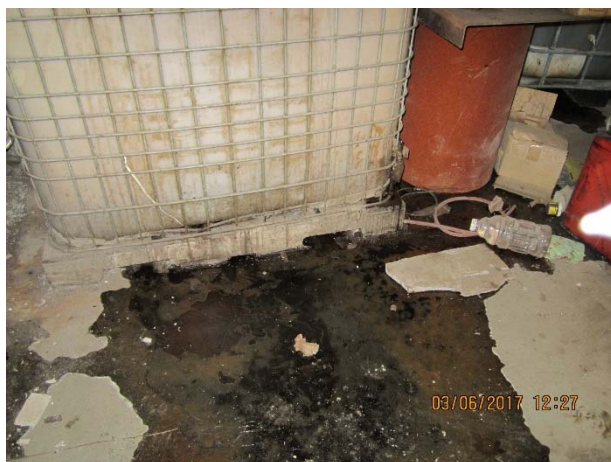
#66 East – West Warehouse

Substance leaking from one or more of the totes stacked in the “empty totes” area. This substance was sticky, like a resin.

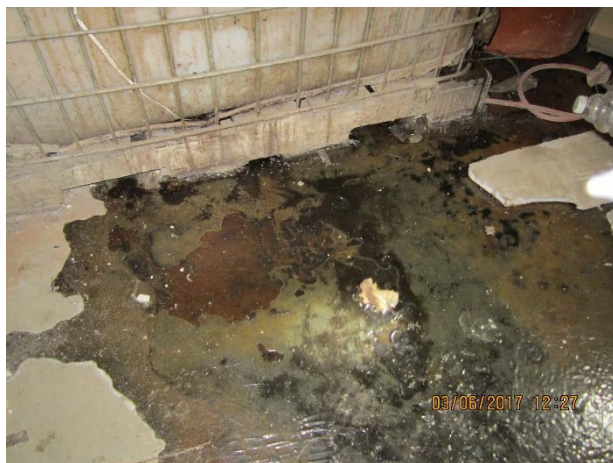
#67 East – West Warehouse

Substance leaking from one or more of the totes stacked in the “empty totes” area. This substance was sticky, like a resin. Room had a rancid odor.

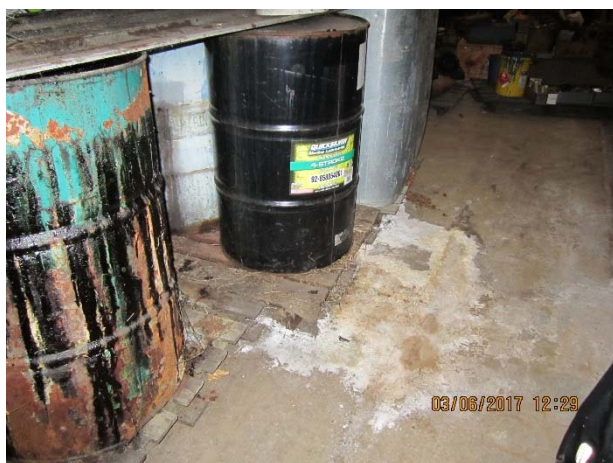
#68 East – West Warehouse

Powdery materials on the floor indicative of spilled material. The contents of these drums is unknown.

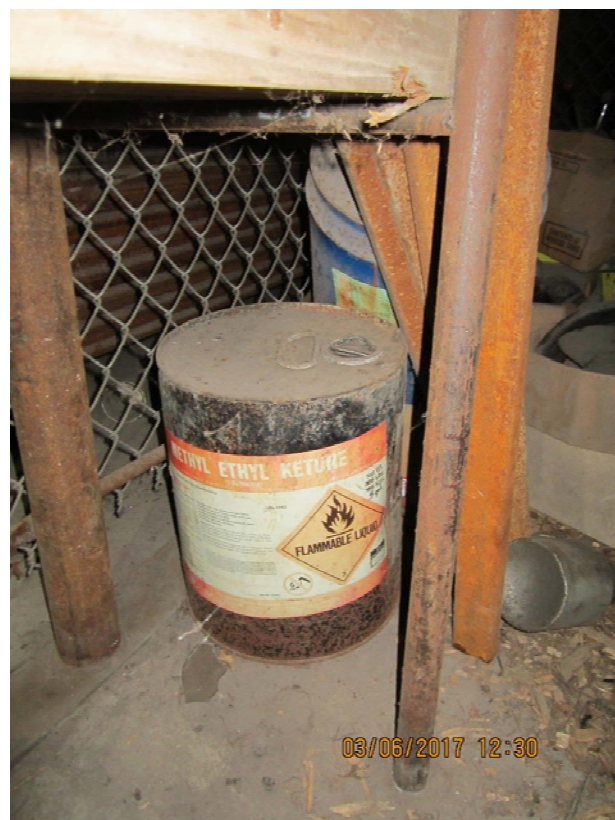
#69 East – West Warehouse

Five gallons of methyl ethyl ketone, found in the caged area along the north wall of the warehouse. Items were not disturbed to view the blue can container located behind the ether, so its' contents are unknown.

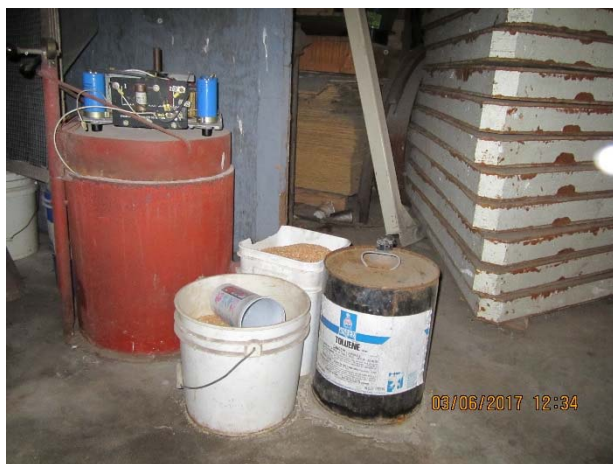
#75 East – West Warehouse

Unknown granular substance in open buckets, adjacent to a five-gallon can of toluene.

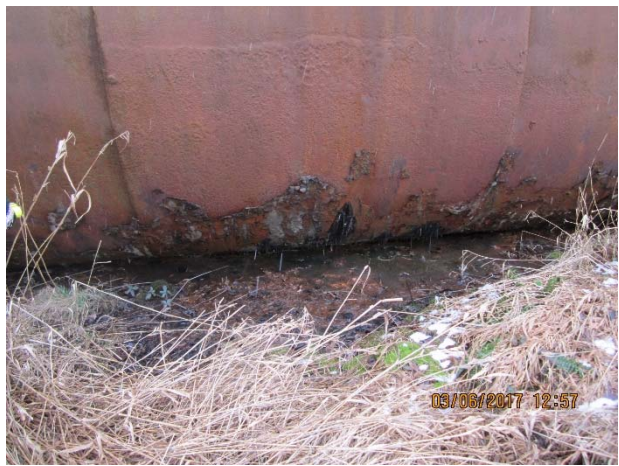
<p>A photograph showing a pile of dry brush and debris. A dark, irregular substance is visible on the ground. A timestamp in the bottom right corner reads "03/06/2017 12:56".</p>
<p>#89 North of Industrial Plant</p> <p>This tank (not one of the 7) appeared to be leaking or has leaked in the past.</p>

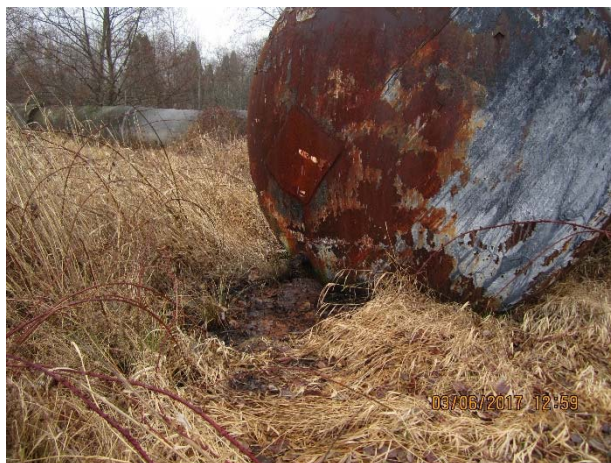
End of tank shown in photos 89 and 90. Note that the port is plugged with wood, and contents appear to have leaked onto the ground.
